UNITED STATES  
DEPARTMENT OF THE INTERIOR  
BUREAU OF MINES

Subject: Report on Investigation of a Minor Coal-Mine Outburst, Glen Rogers No. 2 mine, Raleigh Wyoming Mining Company, Glen Rogers West Virginia, July 26, 1960.

Glen Rogers No. 2 Mine  
Raleigh-Wyoming Mining Co.  
Glen Rogers, West Virginia

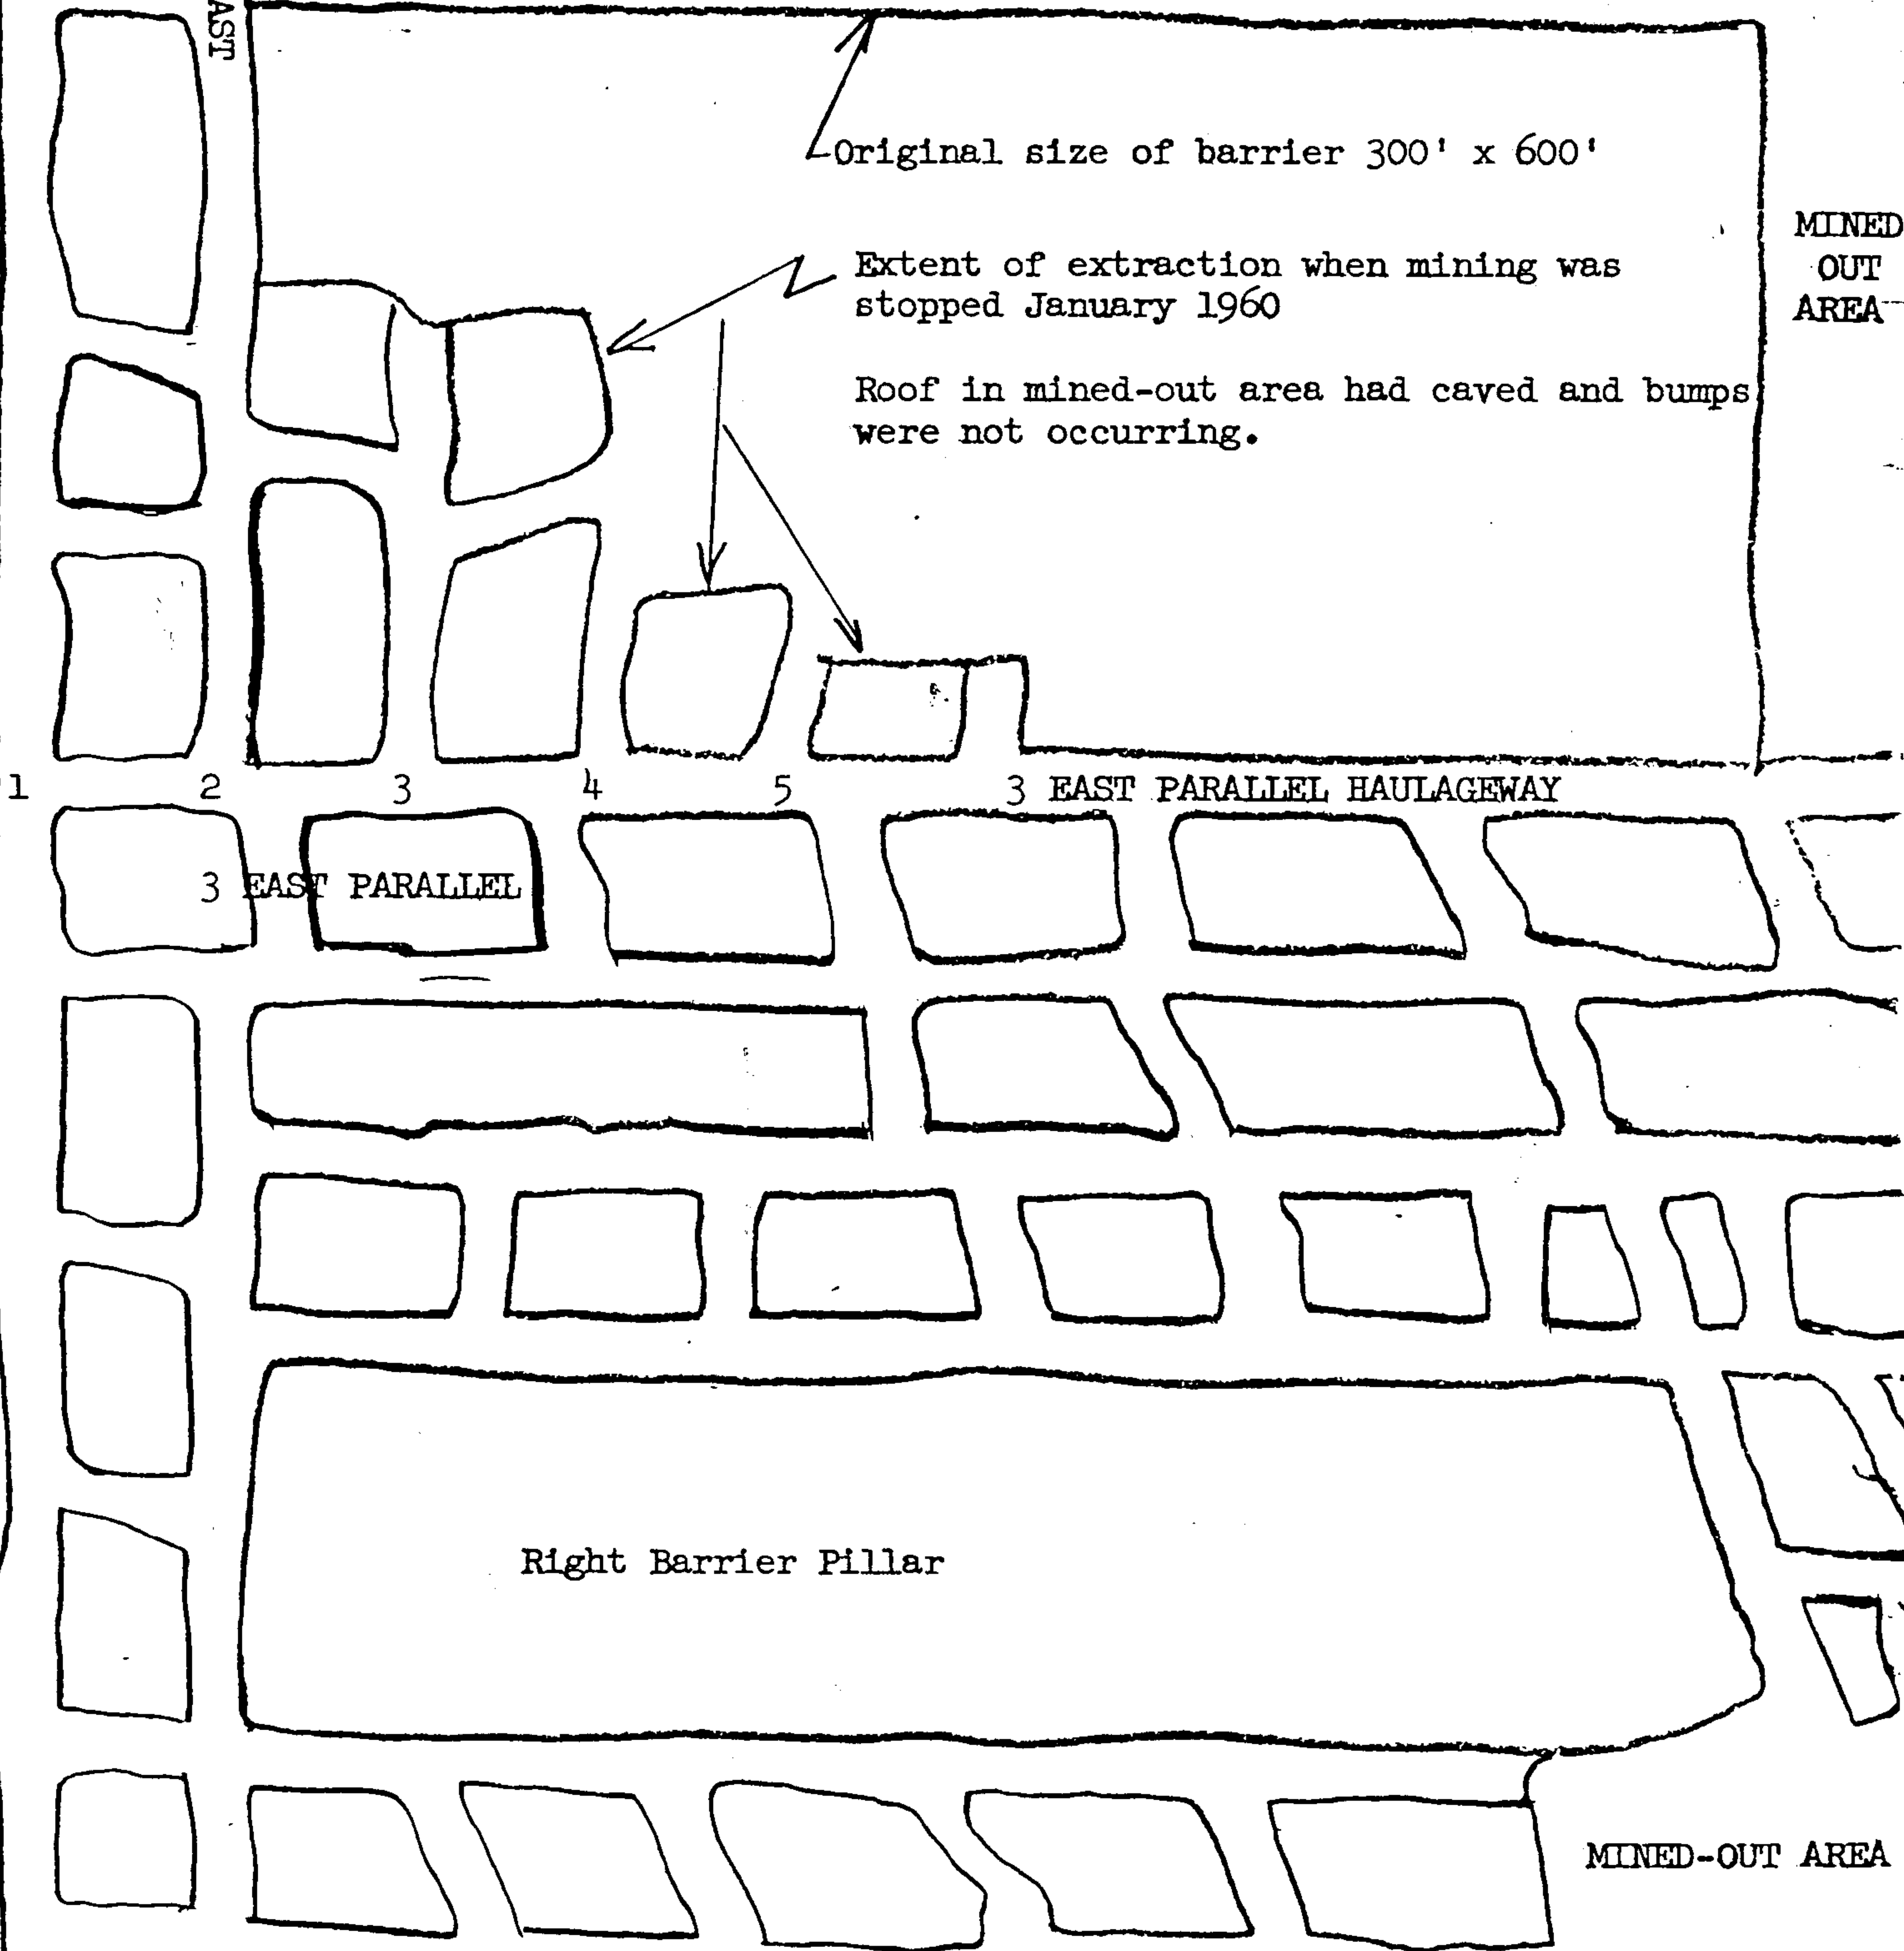
SKETCH - A

The barrier pillar, of which Nos. 2 and 3 room pillars were apart, was originally 600 feet in length and 300 feet in width. The rooms had been developed and the pillars extracted very successfully to the location, as indicated in Sketch A, when mining was stopped temporarily during January 1960 to permit mining of some chain pillars and part of a barrier pillar on the right side of 3 east parallel haulage entry. This delay, plus incomplete mining of several of the 3 east parallel chain pillars and part of the right barrier resulted in additional weight upon the unmined pillars, including those involved directly in the outburst.

During the early part of 1960, the writer visited the 3 east parallel section and discovered that mining of the left barrier pillars had been stopped. This situation was discussed with the mine foreman and with the superintendent. The writer explained that difficulty likely would result by not mining the few remaining pillars in the left barrier, and the fact that partial mining was to be followed in extracting some of the chain pillars and the right barrier pillar. On June 20, 1960, the author visited the 3 east parallel section, (his last visit to this section prior to investigation of the bump) and found that mining of the remaining pillars in the left barrier had resumed on June 15. During the visit on June 20, the writer explained to the section foreman that the delay in mining in that area, in addition to other factors, had resulted in the remaining pillars being definitely stressed, especially the Nos. 2 and 3 room pillars because of their comparatively large dimensions. The Nos. 2 and 3 room pillars, at the time of the bump, were approximately 55 feet in width and 110 and 80 feet, respectively, in length. The writer questioned the foreman as to how he planned to mine these 2 pillars and he replied that he planned to extract them in the identical manner being attempted when the bump occurred. The writer cautioned the foreman to "stay out from in front of these pillars and mine them strictly by taking open-end lifts across the inby ends (gob) until the pillars were reduced to about 40 feet in length". Also, it was suggested that "inducer shots" (blasting) be used in mining these pillars, especially while mining the first 2 or 3 cuts in each lift and continue until the pillars were reduced in dimensions, as suggested. Information concerning the condition and suggestions for mining the 2 pillars in the 3 east parallel section was given to the mine foreman in writing by the writer at the end of the shift on June 20. Furthermore, it was suggested that he check with and advise the section foreman, who incidentally was an extra foreman without experience in bumping conditions. The occurrence of the outburst several days later, however, is evident that sufficient precautionary measures were not taken in attempting to mine the pillars.

Plan showing extent of mining in  
3 East Parallel Barrier section  
January 1960

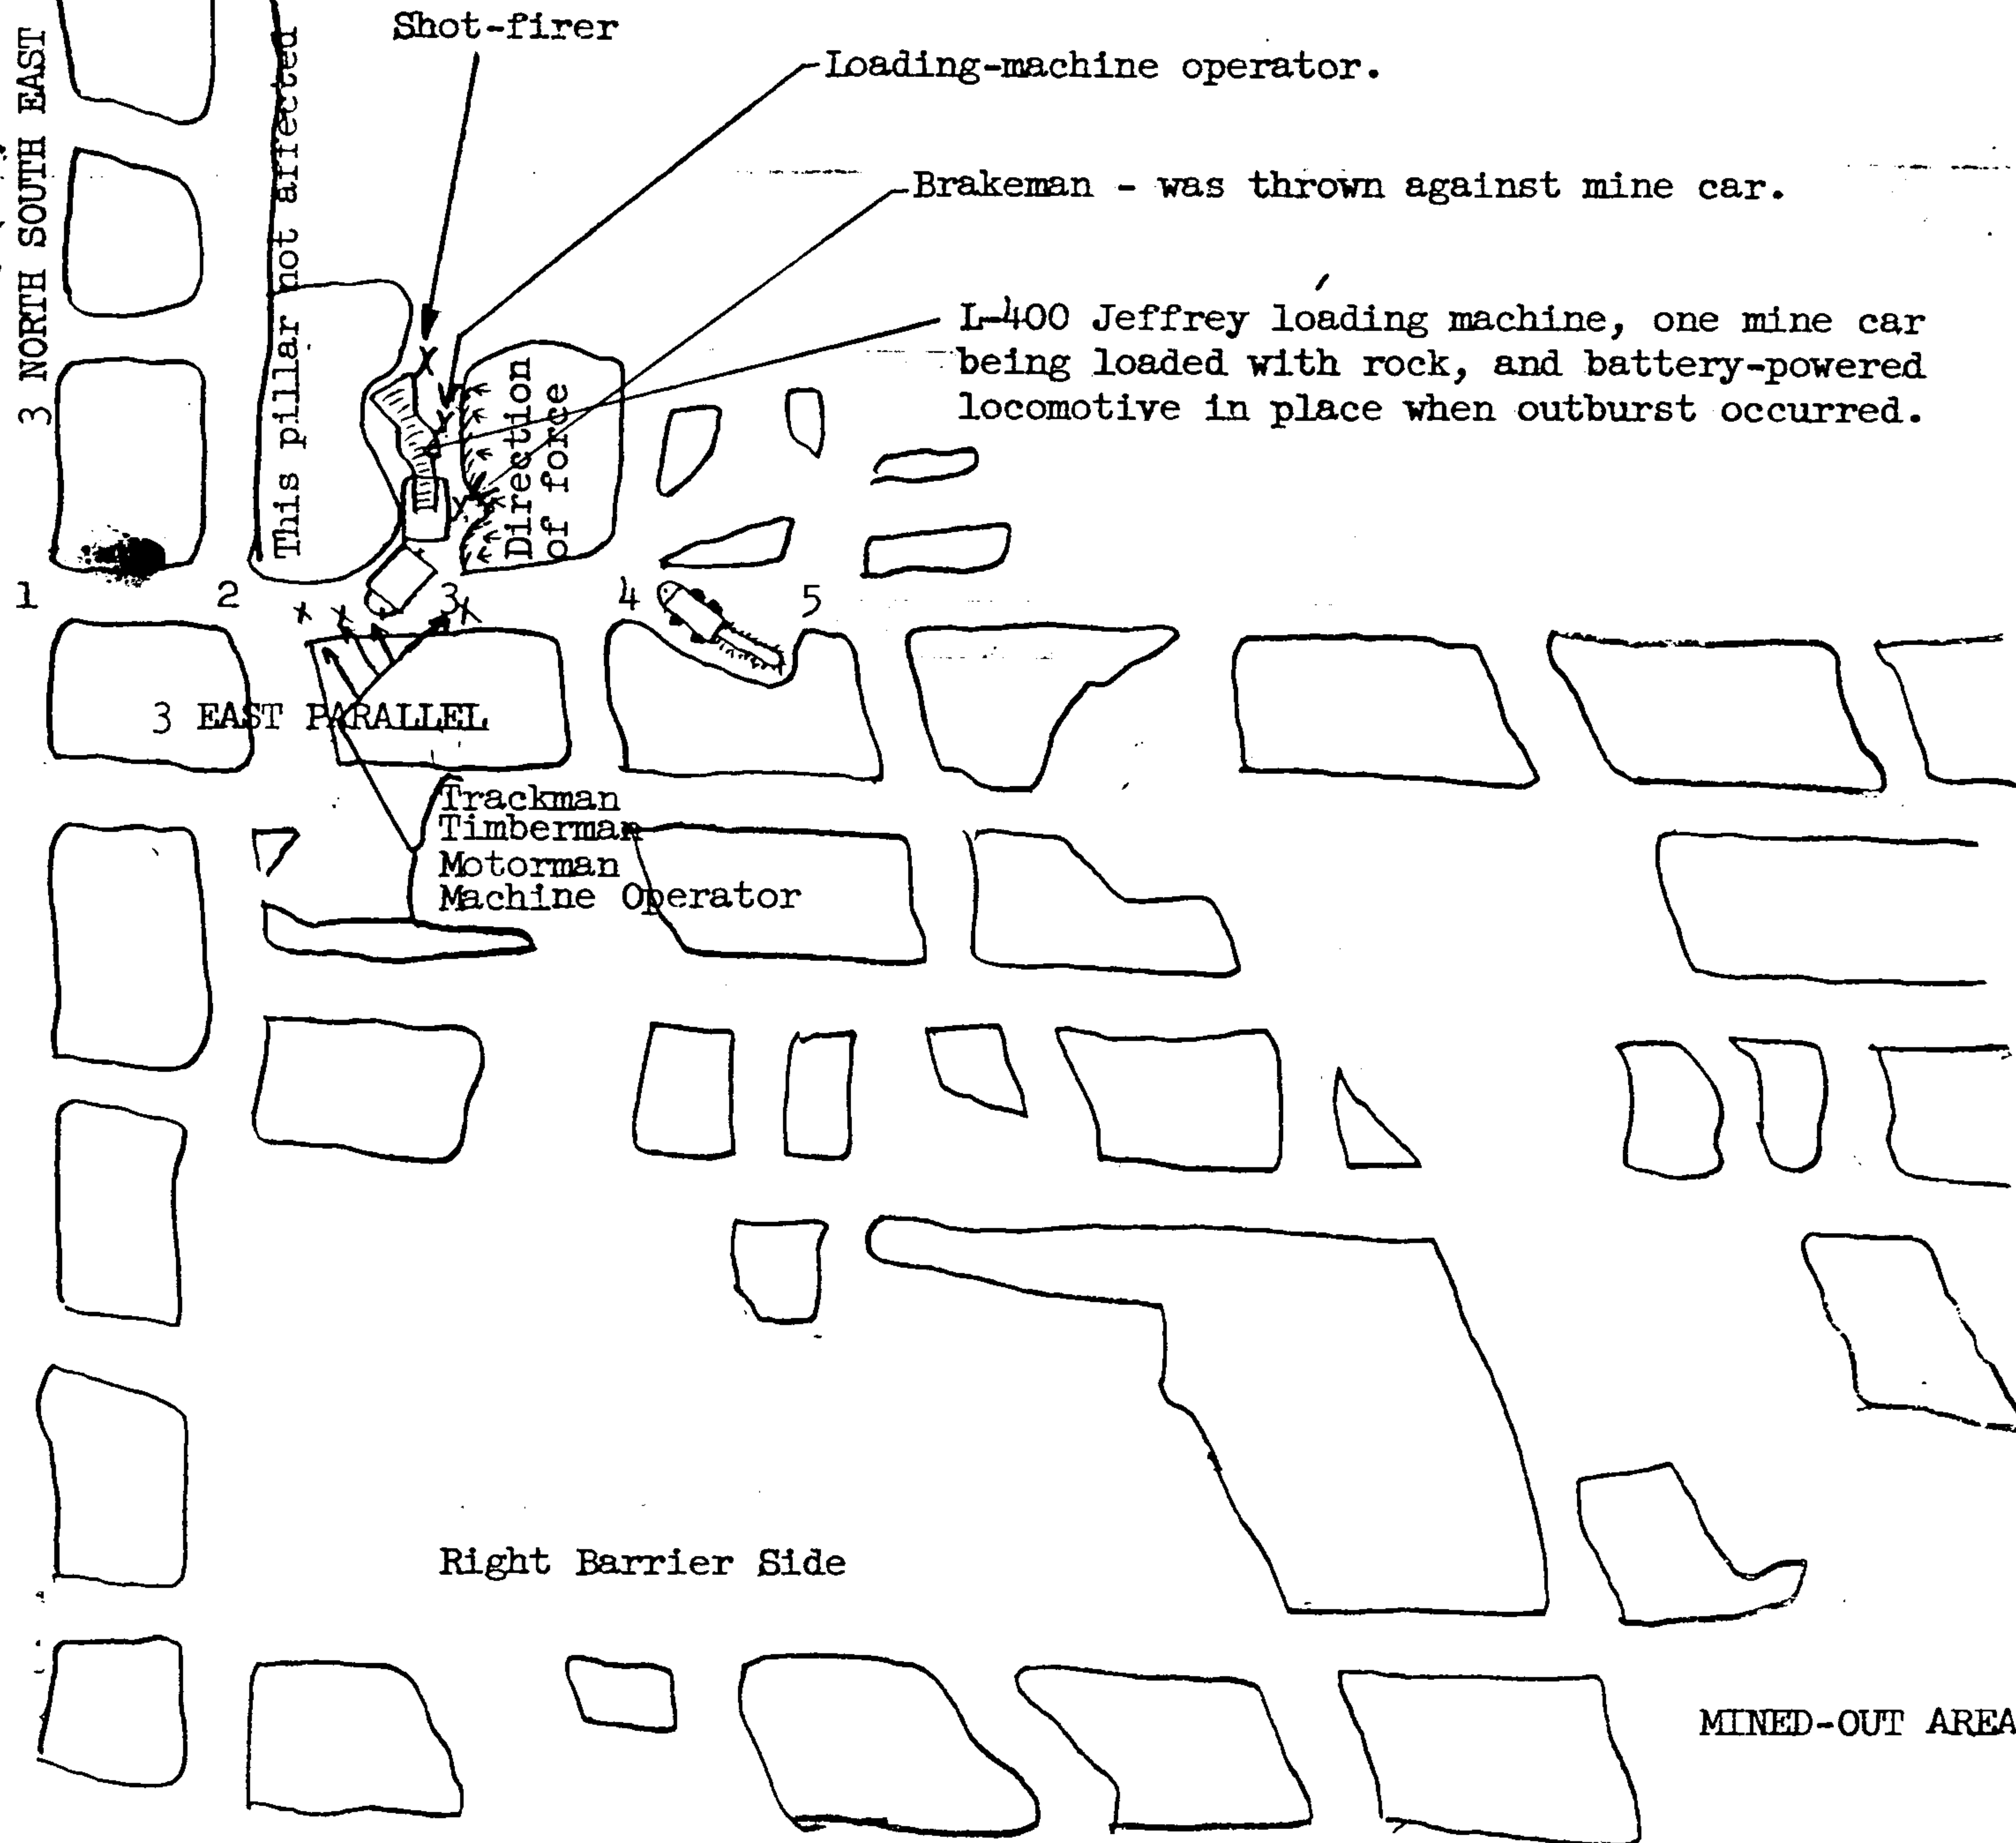
SKETCH - B

The outburst occurred while rock was being loaded with Jeffrey L-400 (track-mounted) loading machine into a mine car in a pillar pocket turned into the side of No. 2 room pillar from the No. 3 room-pillar roadway in the 3 east parallel section (See Sketch B). The pillar pocket (the first cut in the pillar) was turned 40 feet from the gob end of the No. 2 pillar on July 22. After the place was prepared and the cut of coal nearly cleaned up, a section of roof fell next to the face (between face and inby supports). Inasmuch as it was nearing the end of the shift, no other work was done in the place that day. During the idle week-end period, another section of roof fell near the fall of the No. 2 pillar pocket. The maximum thickness of the 2 section of rock was 20 inches and the length was 6 feet and the width was 14 feet. When the men arrived on the section Monday morning, July 25, the foreman had 2 men drill 4 holes and blast the fallen rock. After the rock was blasted and the place examined by the foreman, the loading machine was moved into the place and then started loading the rock. Three cars of rock were loaded, and loading of the fourth and final car (Which was coupled to the permissible-type battery-powered locomotive) was started when the adjacent No. 3 room pillar bumped.

The outburst occurred with sufficient disruptive force to expell coal from the rib of the pillar, starting at a point 25 feet from the outby end and terminating about 5 feet from the inby end of the pillar, or a distance of 55 feet along the pillar. Unfortunately, the brakeman, who was watching the rock being loaded, was opposite the point where the stress wave released with the greatest force, as indicated by the resultant cavity 4 to 6 inches in height between the coal and roof and 6 feet in length. The brakeman was thrown against the side of the mine car and the loading-machine operator, who was struck by the outrush of coal, was thrown against the chassis of the loading machine; both men were partially covered with coal. At the time of the outburst, there were 4 men, including the motorman, at the entrance to the No. 3 room, and a shot firer, who, only a few minutes previously, had been sprinkling water on the rock during loading operations, was 10 feet inby the loading-machine operator. The concussion staggered the employees at the entrance to the place, and the shot firer was knocked down, but fortunately being in the center of the place and out of direct line of the stress wave, escaped injury. The foreman was 300 feet from the scene of the outburst.

The cause of this minor coal-mine outburst resulted from a combination of conditions and factors mentioned above, and recommendations made during and following the investigation include:

Plan indicates extent of extraction on day outburst occurred.

Plan showing scene of coal-mine outburst that occurred in No. 3 room pillar, 3 East Parallel Section - July 25, 1960.

1. Pillars should be recovered by the open-end lift method.
2. Adjacent pillars, where possible, should not be extracted from the same roadway.

3. A system of mining should be adopted that will produce the least number of critical areas during second or retreat mining.

4. The mining system should require that the coal pillars be developed as nearly uniform in size and in shape, as practicable so as to minimize overloading of individual pillars.

5. To assist the roof in caving, complete extraction should be striven for, and pillar remnants that tend to retard caving should not be left in the goaf. If it is not possible to recover a pillar remnant that is of such size as to delay caving, then its load-carrying capacity should be destroyed by blasting.

6. In pillar recovery in areas where massive sandstone roof is near or immediately over the coal and resists caving and where the floor is hard and resists yielding, every effort should be made to extract the coal pillars in a manner that will permit orderly distribution of induced mining stresses.
